# Design Implementation Guide

## Cisco 2500 Flash Upgrade

### Overview

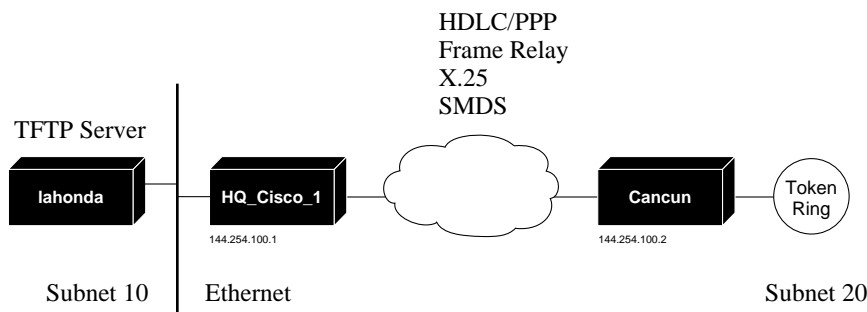
Figure 1. A Sample Network Map

The sample diagram shown in Figure 1 assumes the following:

- 1 144.254.0.0 is a class B network.
- 2 An 8-bit subnet scheme is used with netmask 255.255.255.0.
- 3 144.254.20.0 is subnet 20 with Token Ring media.
- 4 144.254.10.0 is subnet 10 with Ethernet media.
- 5 Lahonda is the TFTP server with IP address 144.254.10.10.
- 6 HQ\_Cisco\_1 is the Cisco router on subnet 10.
- 7 Cancun is the remote Cisco 2500 router that needs to be upgraded.
- 8 The two sites are connected via a WAN cloud with serial interfaces IP numbered as shown below.
